Technical Preservation Services  
Preservation Assistance Division  
National Park Service  
U.S. Department of the Interior  
Washington, D.C.

# Interpreting the Secretary of the Interior's Standards for Rehabilitation

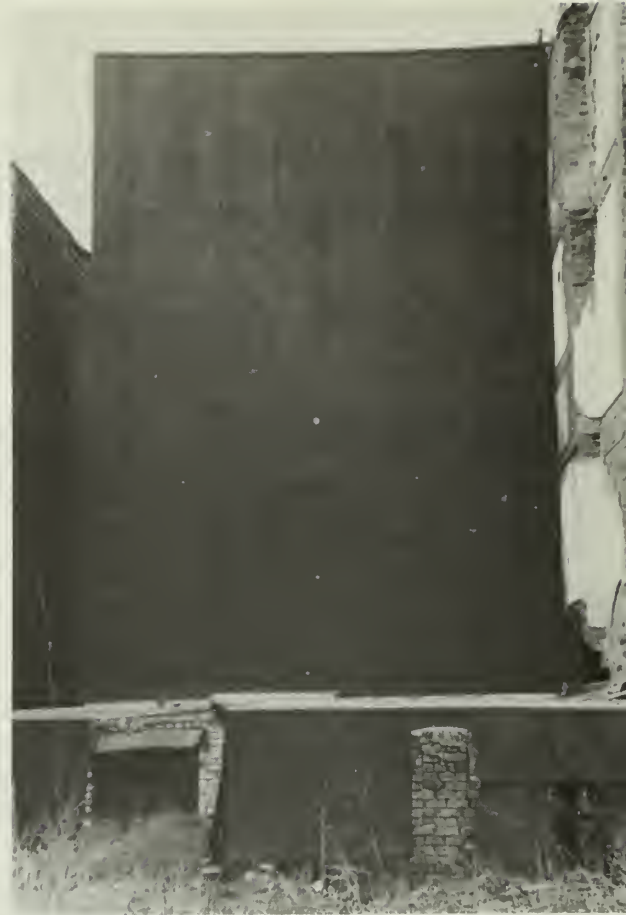
2. Limited demolition at the rear of the building had already occurred and protective boards had been applied.

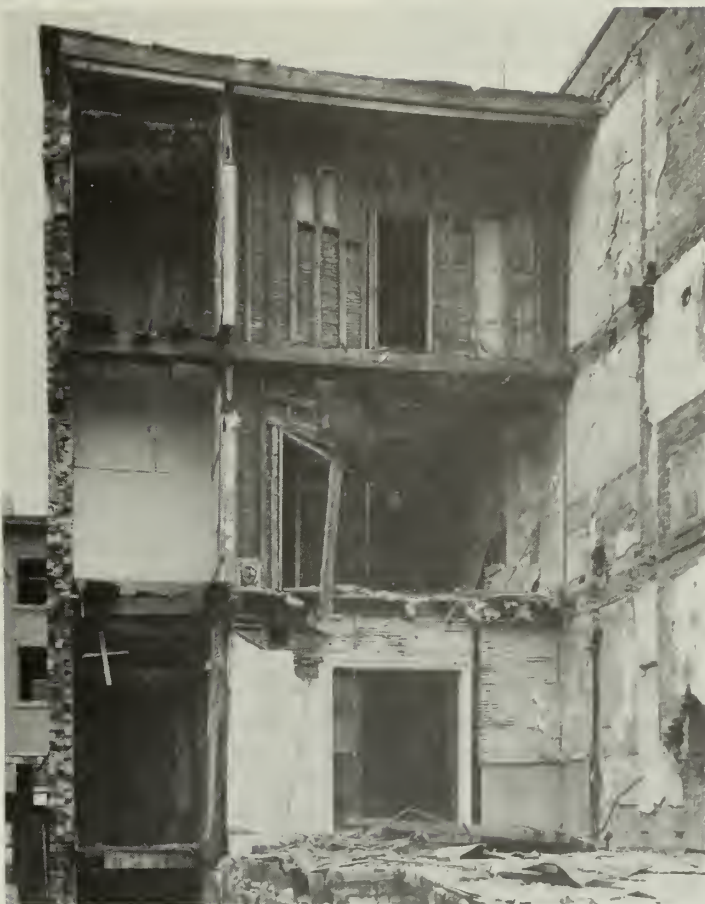
5. Crucial to the decertification of the structure were additional photographs documenting the condition of the rear of the building prior to rehabilitation. After removal of the boards, this new information showed that barely 1/3 of the building remained.

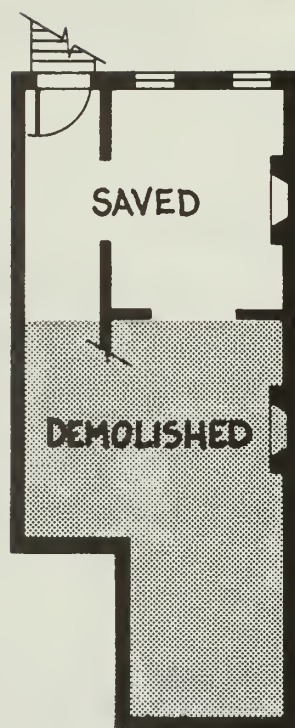
6. The plan indicates the extent of material loss that had occurred prior to rehabilitation, including exterior and interior features.

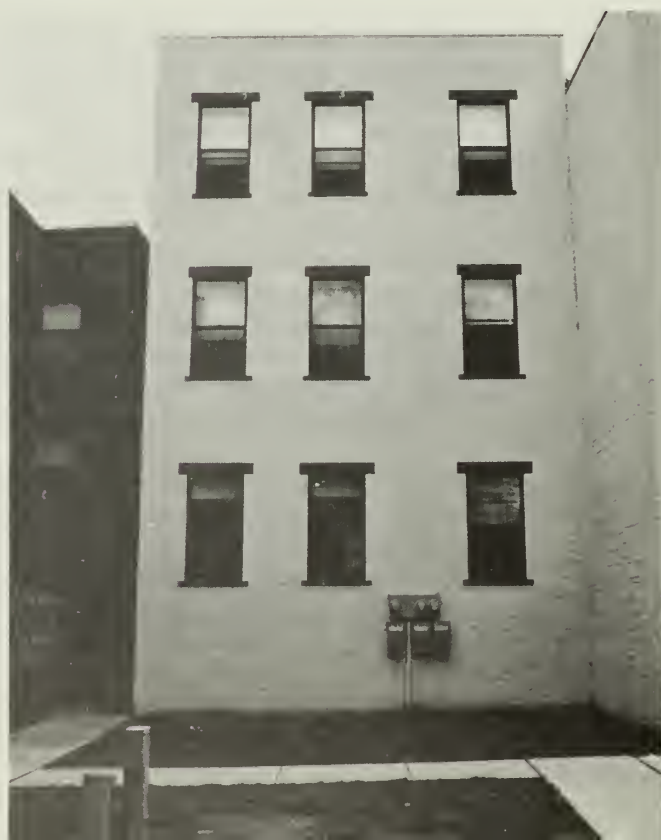
7. The rear of the building and major portions of the interior required extensive replacement of historic material with new material.

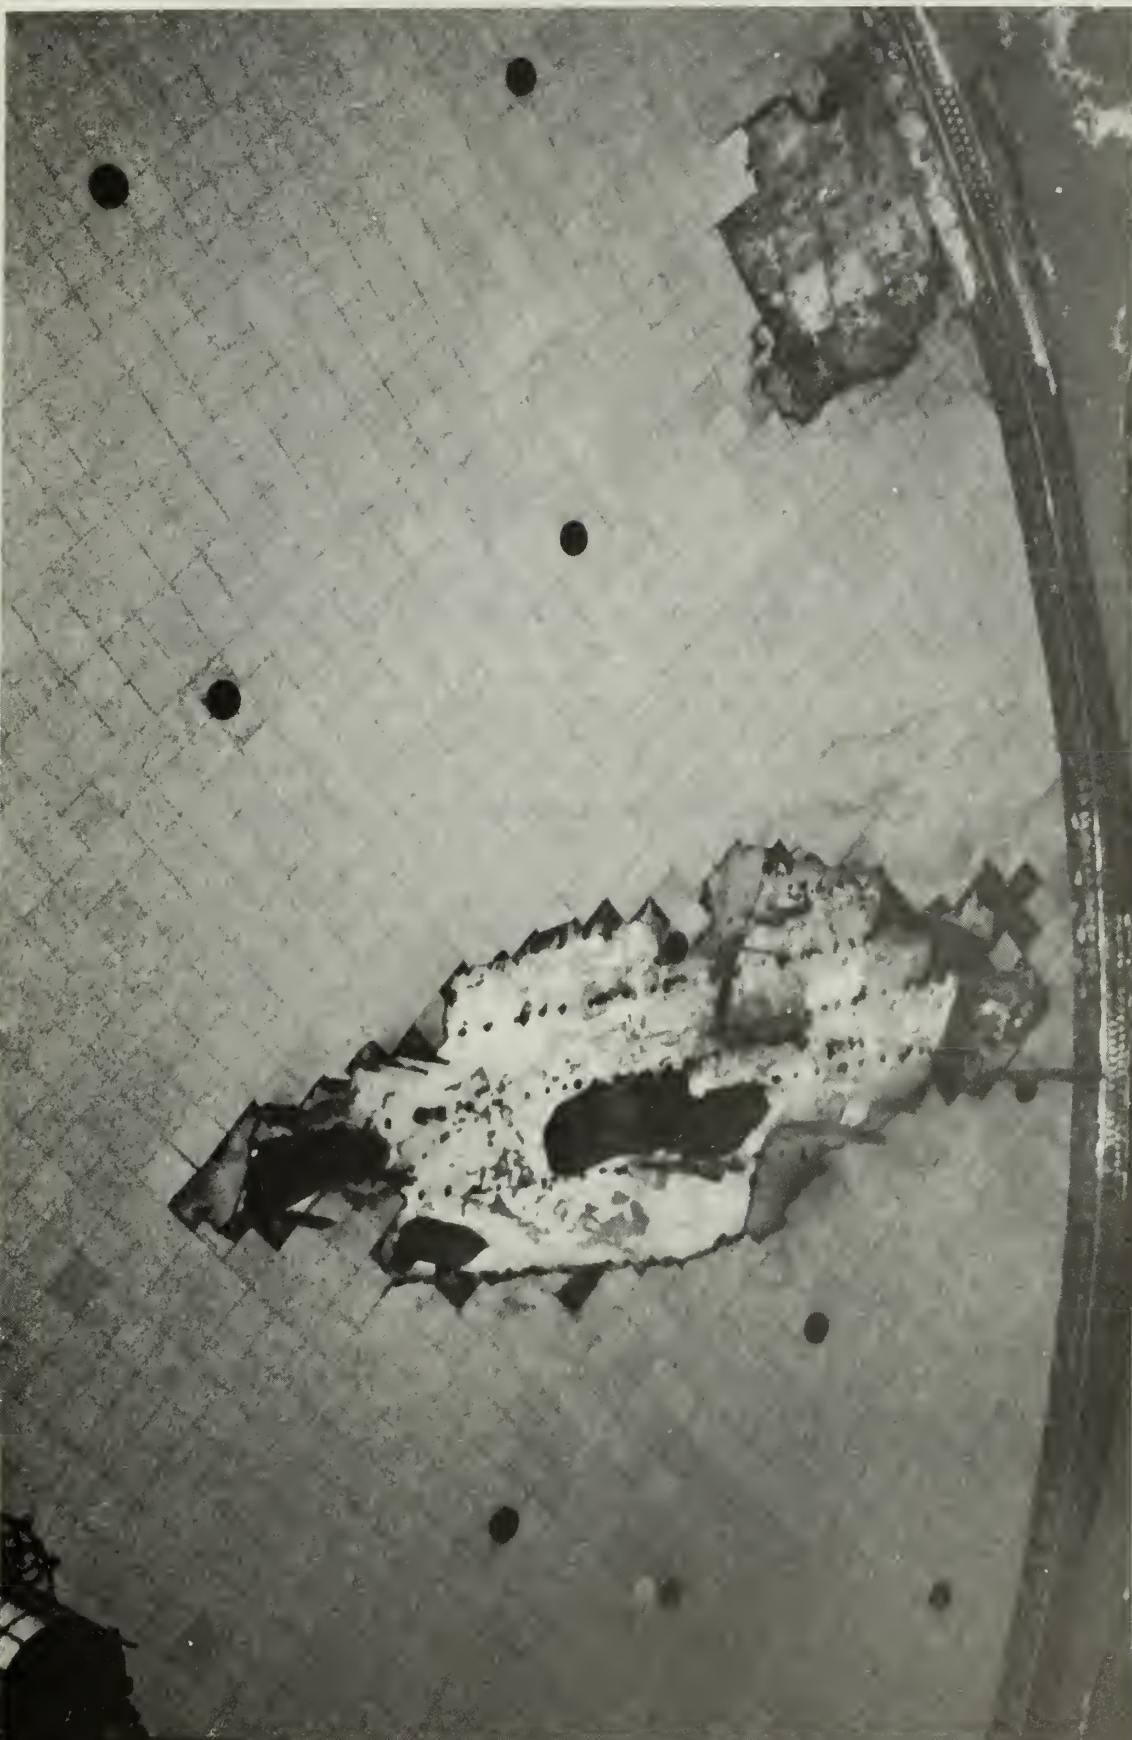
5. Damaged ceiling, due to moisture from roof leaks, buildup of pigeon droppings above, and lack of heat.

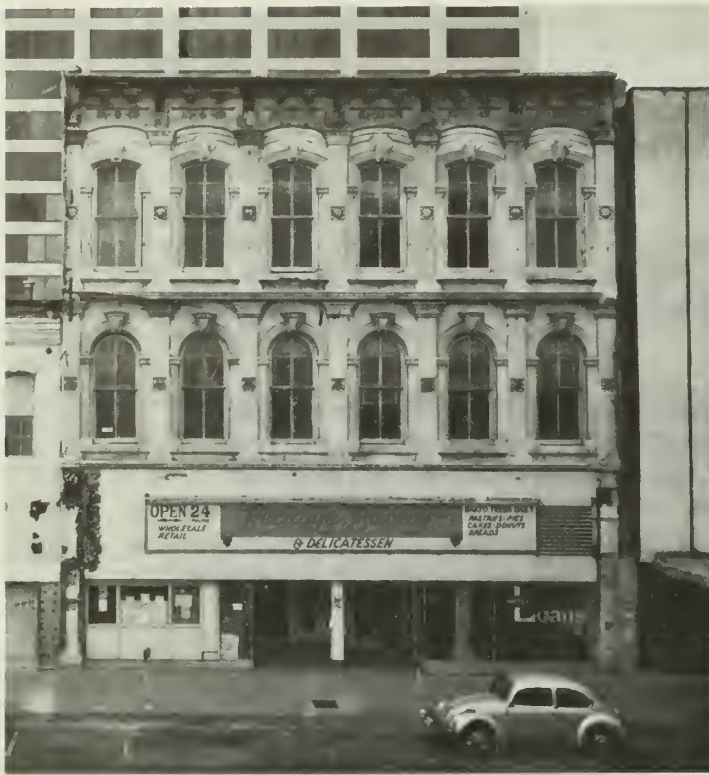
1. At the outset of rehabilitation, an 1866 limestone building was missing its ornamental cornice; and the ground level storefront had been extensively altered.

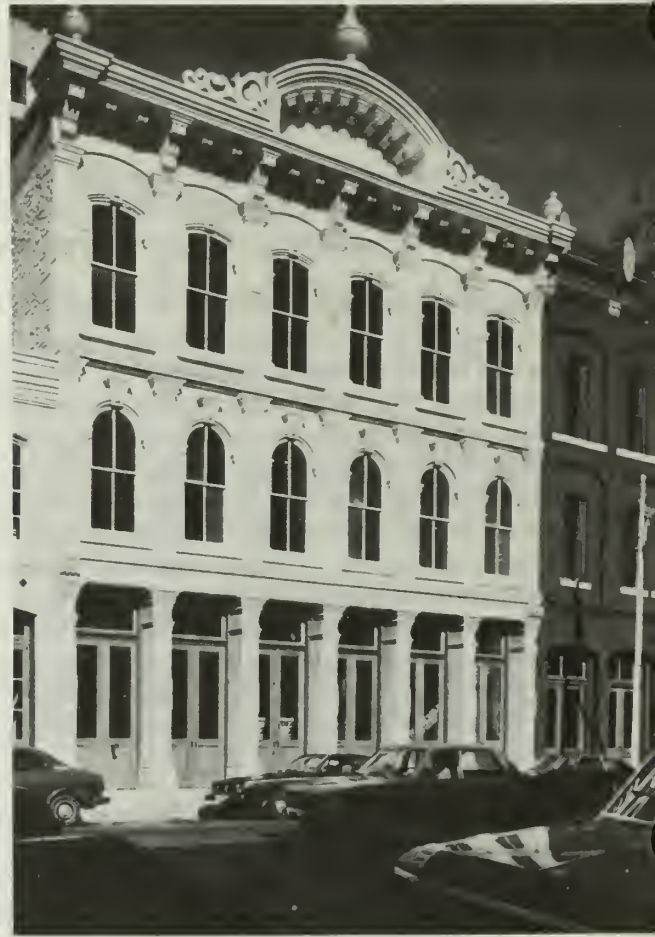
3. In addition to restoration of the storefront using matching materials, this photograph of finished work shows an acceptable use of substitute material (in this case, fiberglass) to fabricate the missing pressed metal cornice.

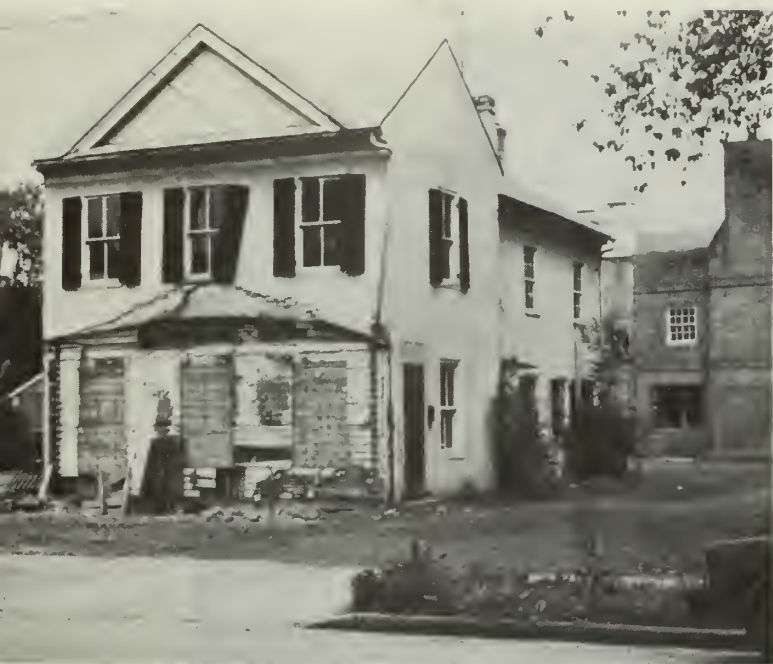
1. Front and side elevations of a ca. 1865-1870 wood frame building prior to rehabilitation. Stucco had been applied over the exterior wood at a later date and had caused rotting and termite infestation of historic wood. The building was certified as meeting Part 1 integrity requirements in its deteriorated and damaged condition.

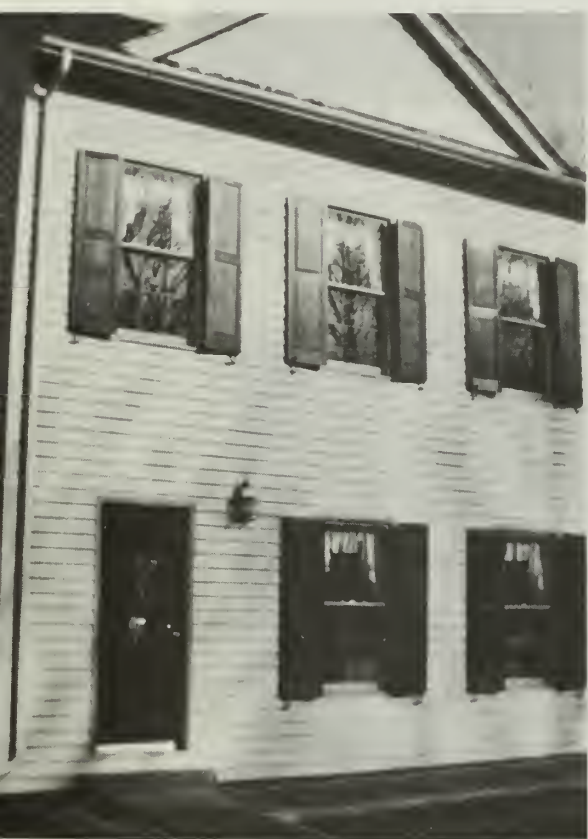
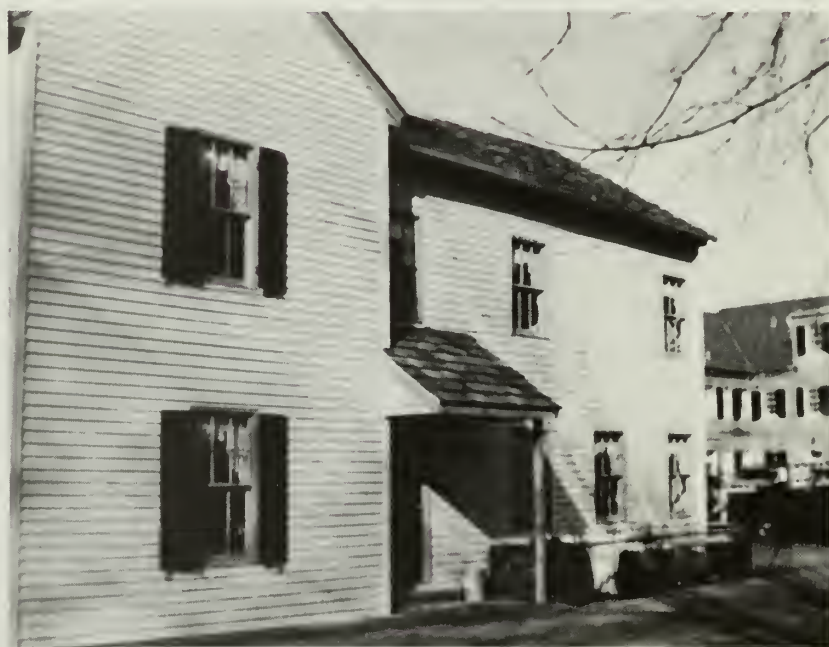
2, 3. The same building shown after rehabilitation is essentially new construction. Rather than targeted replacement of deteriorated materials, the owner replaced all of the siding, roofing, windows, sills, shutters, and trim. Some of the replacement features, such as the use of thick, cedar shakes on the roof and side porch were considered inappropriate. The owner was denied Part 2 certification on appeal. As a result of material loss during rehabilitation and the earlier loss of interior features and spaces, the Part 1 certification was also withdrawn because the building could no longer meet integrity requirements.

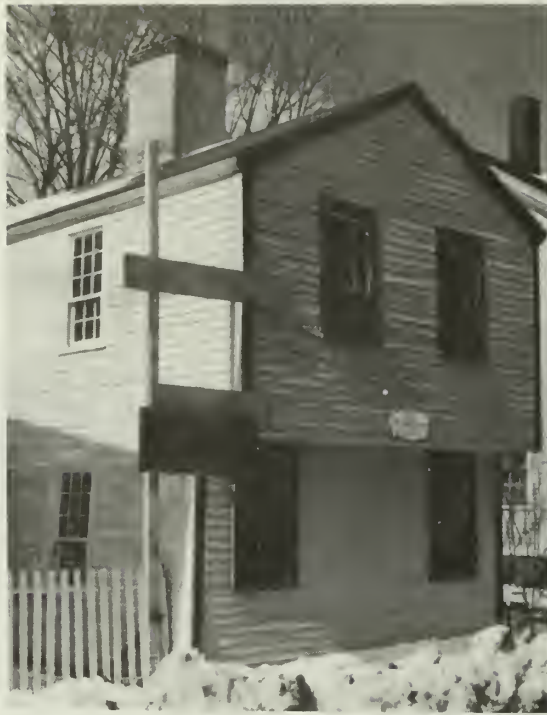
4. A ca. 1769 building was certified in the Part 1 application in its existing condition, which involved extensively deteriorated exterior wood clapboarding, sheathing and window sash. On the interior, some original framing members were intact, while others were repaired or replaced.

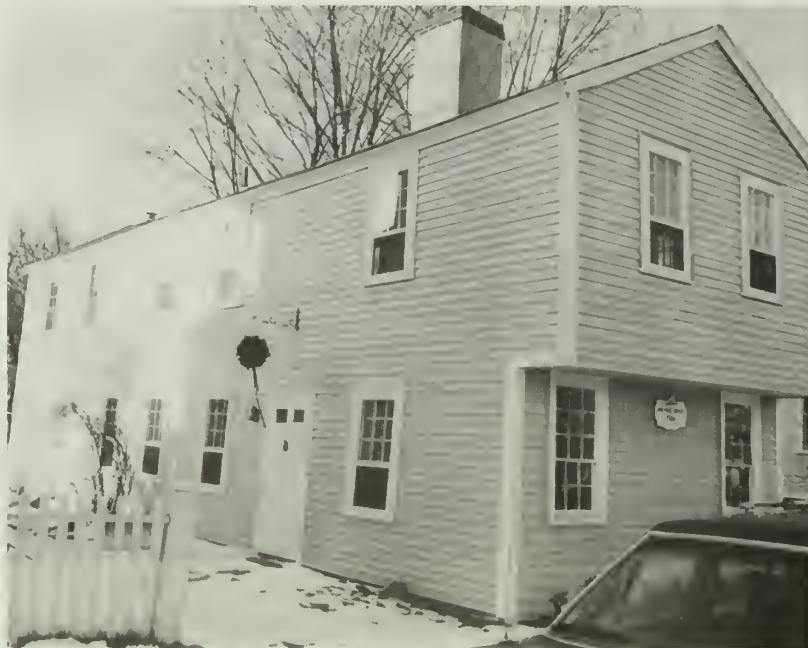
5. Completed exterior work shows the extent of replacement of deteriorated exterior wood materials and features. All siding and sheathing was replaced with new wood. Window sash and frames are also new. The applicant documented areas that needed to be replaced because of extensive deterioration as well as those portions, such as the cornice molding, that could be retained and preserved.

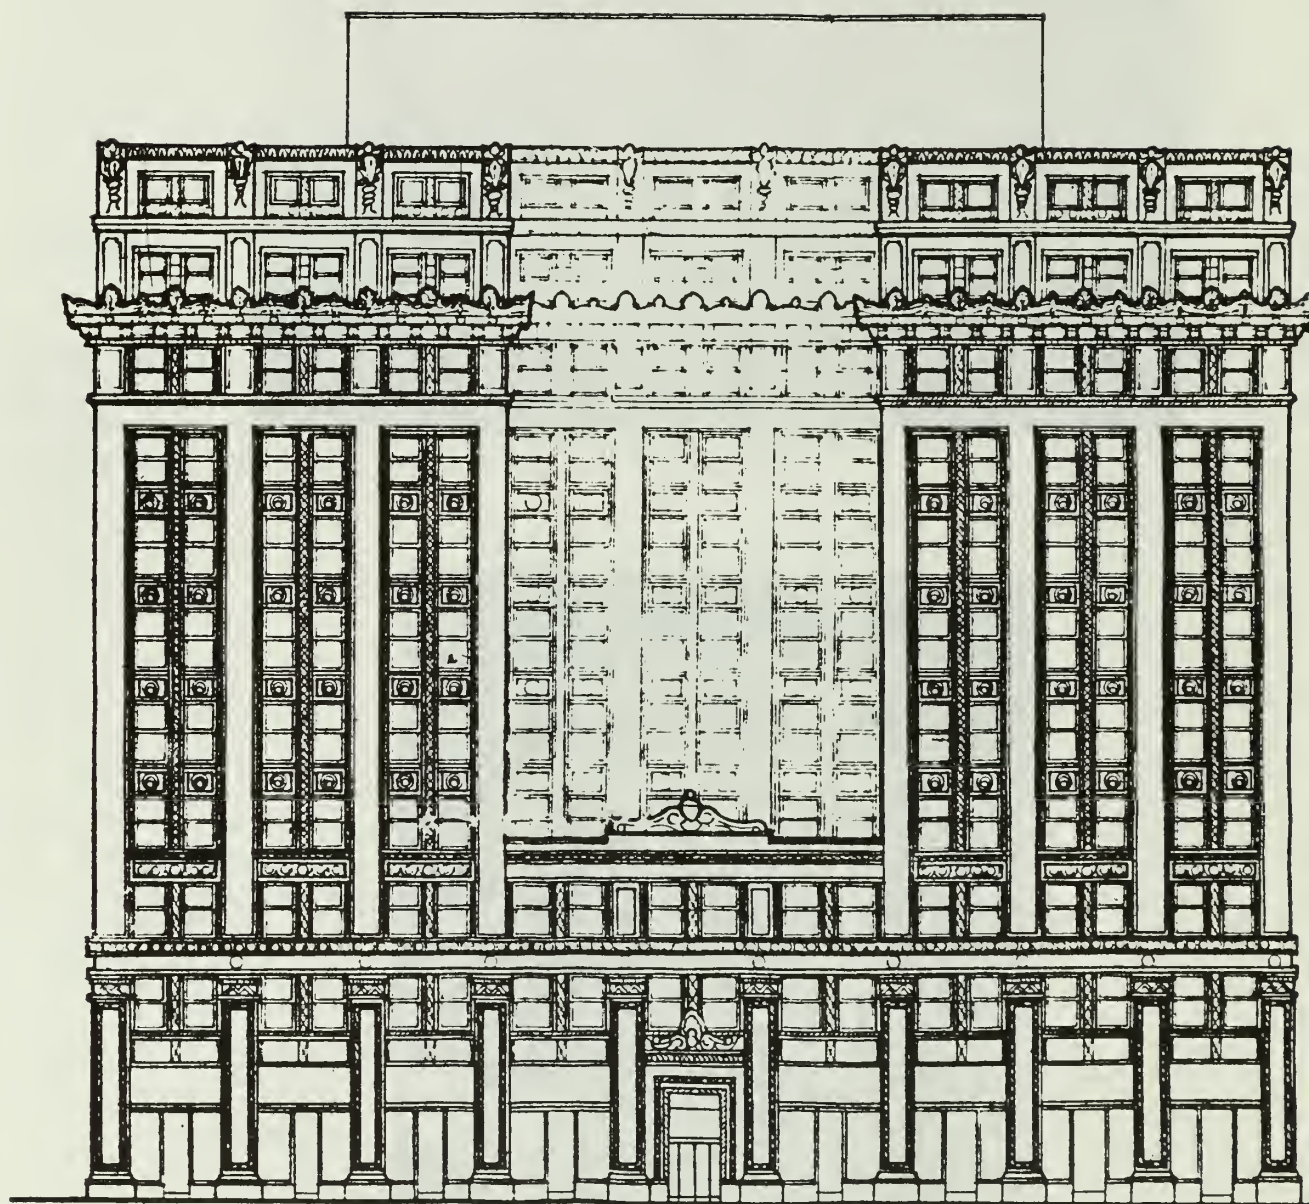
3. The proposed rooftop addition, like other designs submitted, would have obscured the appearance of the character-defining cornice against the sky.

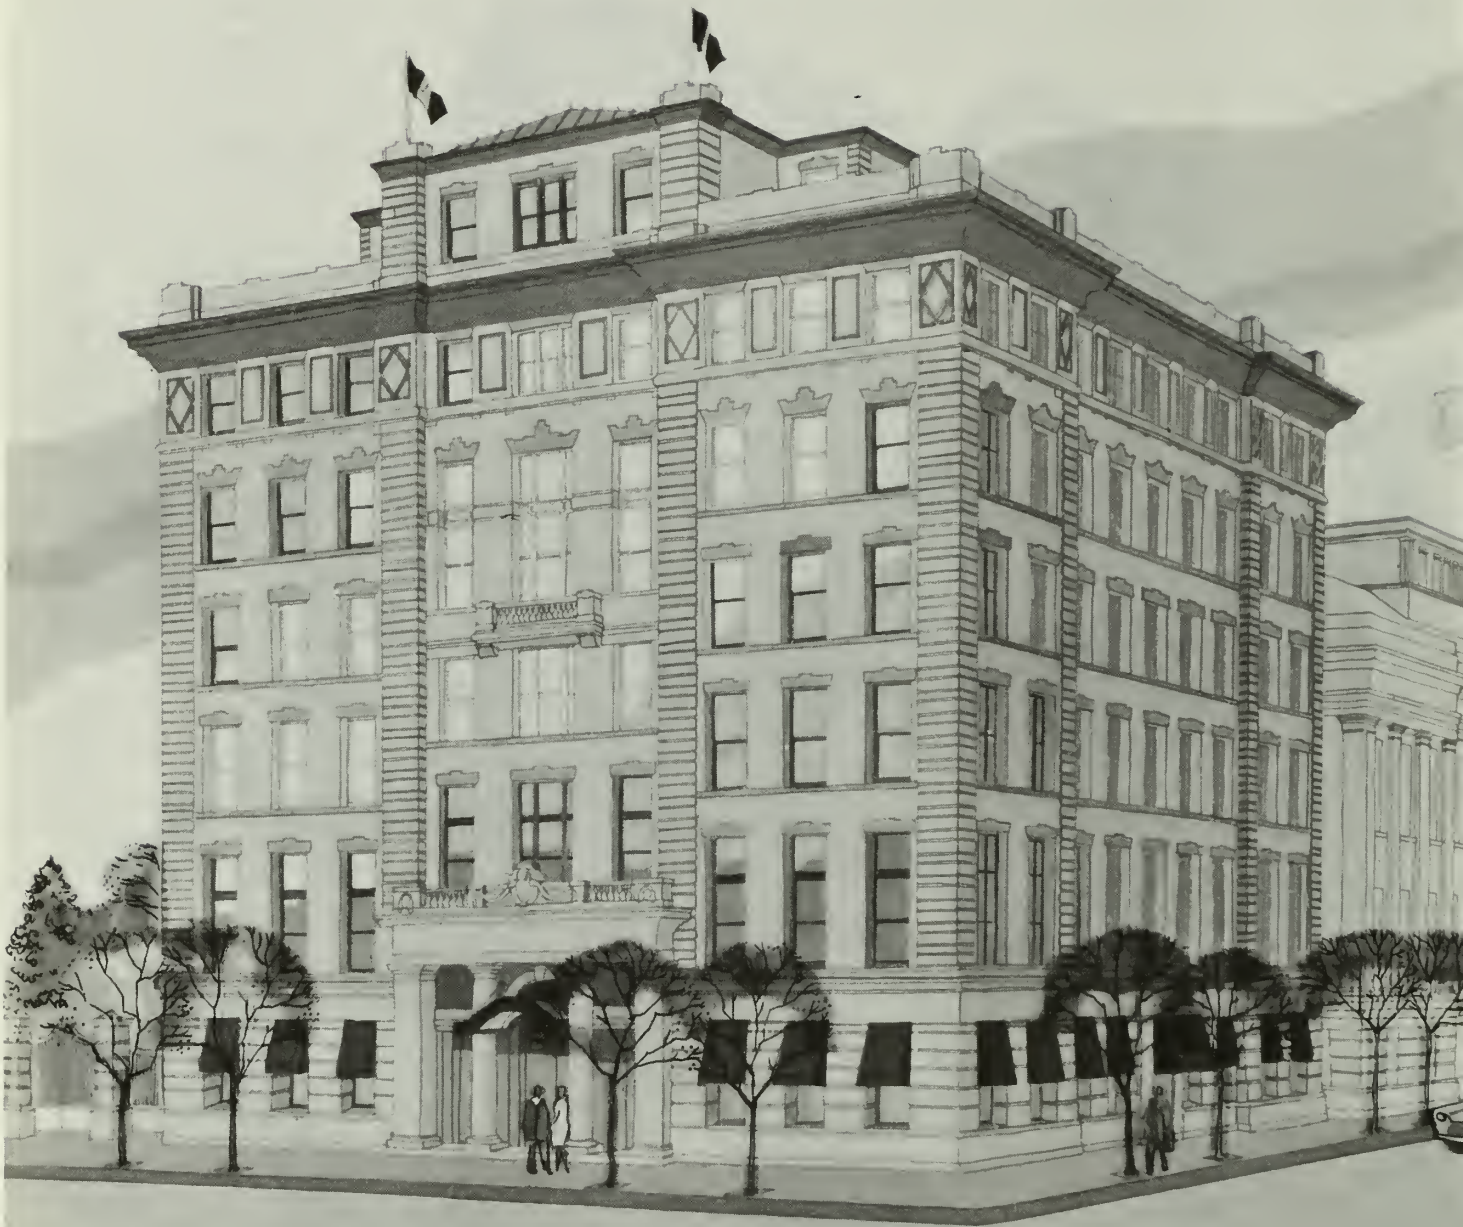
2. The proposed penthouse addition with the three bay portion across the front was determined not to meet the Standards for Rehabilitation. The change in the form of the building; the conscious attempt to tie the addition to the historic building through use of replicative detailing; and the alterations to the historic roof balustrade, were all factors cited by the National Park Service.

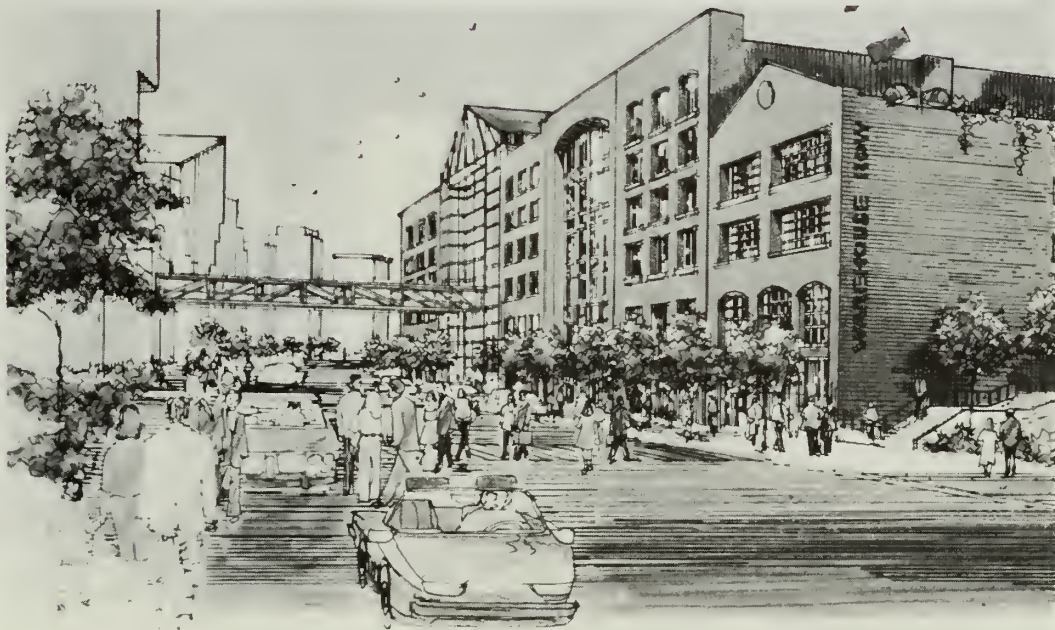
3. This artist's rendering, looking south, shows the proposed "pedway" connecting a public plaza across the street to the renovated warehouses. This new horizontal element, visually intrudes on the historic panoramic vista of the warehouses and was a cause for denial of certification. The glass enclosure over a historic street was a separate cause for denial.
